# TECH TIPS

**PART NUMBERS AFFECTED:** S16711, S16982

**MANUFACTURER:** NISSAN

**YEAR:** 1981-1989

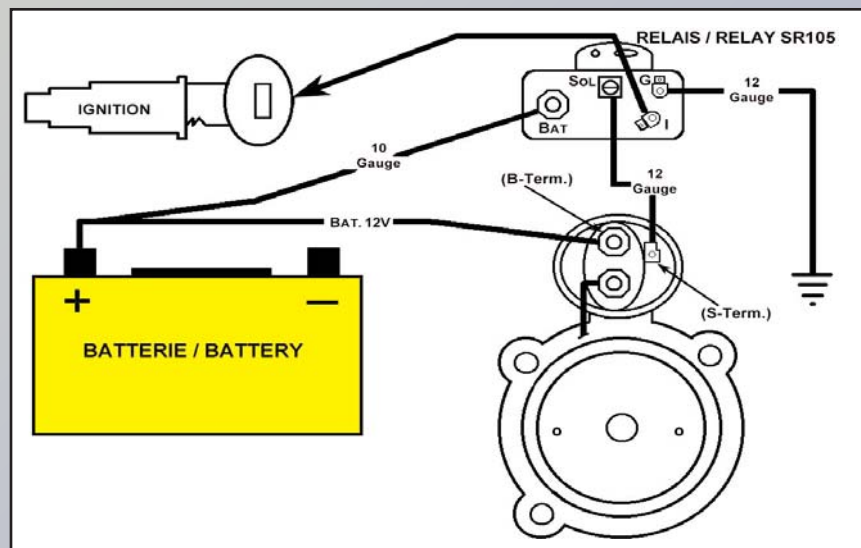
## **RELAY WIRING DIAGRAM:**

REPLACING NISSAN STARTER MOTORS USED ON 1981 TO 1989 NISSAN 200SX, MULTI, PICK-UP, AND STANZA MUST ALWAYS BE REINSTALLED WITH THE HEAT PROTECTION SHIELD IF SUPPLIED TO PREVENT INTERMITTENT OPERATION OF THE STARTER MOTOR. IN SOME CASES THE HEAT PROTECTION SHIELD WILL NOT ELIMINATE THE PROBLEM COMPLETELY, A HIGH RESISTANCE PROBLEM CAN BE CREATED DUE TO THE AGE OR THE CONDITION OF THE VEHICLE. THE HEAT OF THE ENGINE CAN ALSO AMPLIFY IT.

TO RECTIFY THIS PROBLEM INSTALL A STARTER RELAY ( **BLUESTREAK PART NUMBER SR105** )

1. DISCONNECT NEGATIVE BATTERY CABLE FROM BATTERY.
2. SELECT A LOCATION CLOSE TO THE STARTER TO MOUNT THE RELAY. THE RELAY SHOULD BE MOUNTED IN AN AREA WITH THE TERMINALS FACING DOWNWARD TO PREVENT THE ENTRY OF WATER OR DIRT INTO THE RELAY. DRILL A 1/8" HOLE WHERE IS TO BE INSTALLED, AND MOUNT THE RELAY WITH A SHEET METAL SCREW.

3. DISCONNECT THE STARTER SWITCH WIRE FROM THE START CONNECTOR OF THE STARTER SOLENOID ( S-TERM.), AND ATTACH IT TO THE RELAY ( I ) TERMINAL.
4. ADD A #12 GAUGE WIRE FROM (SOL) TERMINAL ON THE RELAY TO THE (S-TERM) ON THE STARTER SOLENOID.

5. ADD A #10 GAUGE WIRE FROM THE BATTERY (POSITIVE TERMINAL) TO THE RELAY (BAT) TERMINAL.
6. CONNECT A #12 GAUGE WIRE FROM THE (G) TERMINAL ON THE RELAY TO GROUND.

7. TAPE ALL EXPOSED CONNECTIONS. USE WIRE TIES TO SECURE THE RELAY WIRES AND ROUTE THEN AWAY FROM POTENTIAL DAMAGE AREAS SUCH AS EXHAUST MANIFOLDS, SHARP CORNERS, OR MOVING PARTS.

8. RECONNECT NEGATIVE BATTERY CABLE TO BATTERY. INSTALLATION IS NOW COMPLETE.
